The Hadrian, New York

The Hadrian, Manhattan - New York

Memoirs of Hadrian

In New York, an early 20th century building recovered its former glory following renovation of its façade and restoration of its cornice.

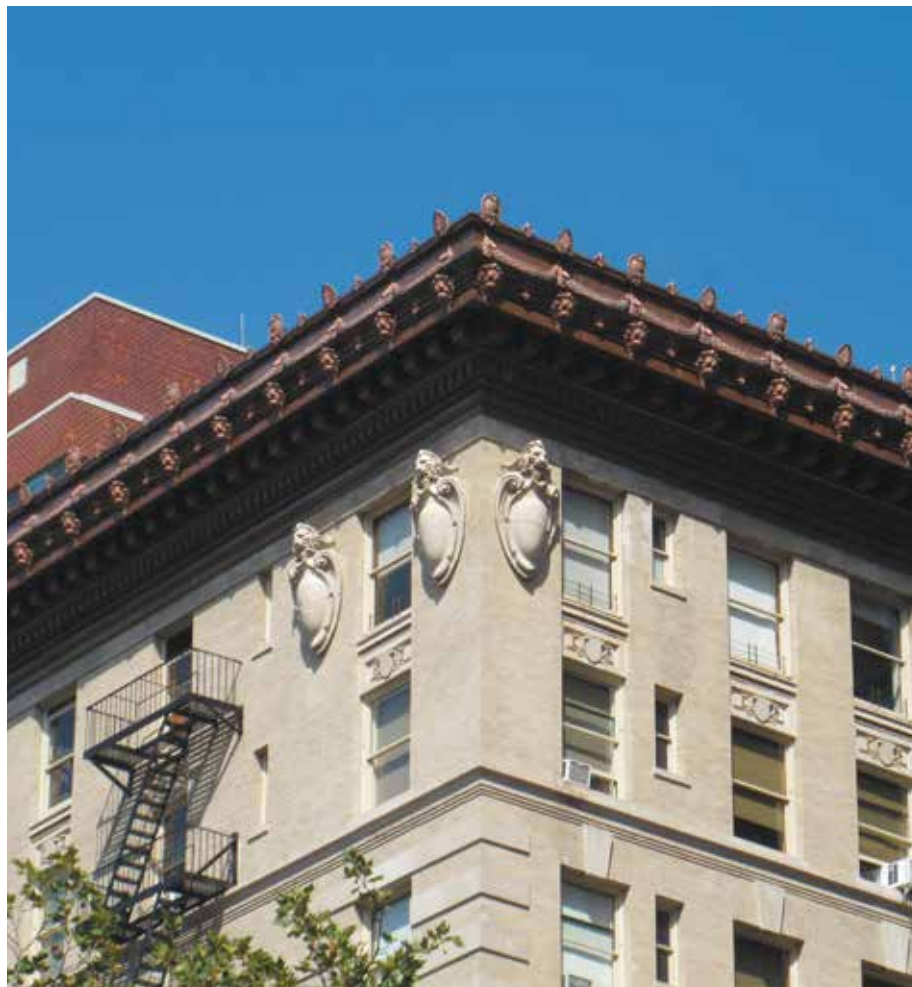
“After a long interactive process, the 67 metres of copper cornice were delivered to the New York work site.”

a slight trace remained, and how to find a company capable of carrying out work using traditional know-how while meeting modern-day standards? The various parts were produced remotely in the VMZINC® workshops in Bray-et-Lû. After a long interactive process, the 67 meters of copper cornice were delivered to the New York work site. Prefabrication remotely from

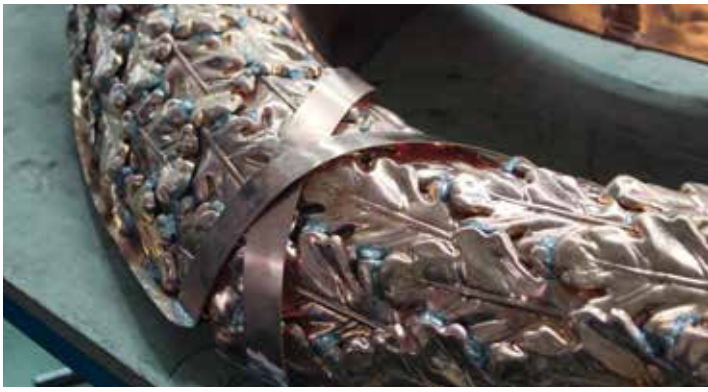
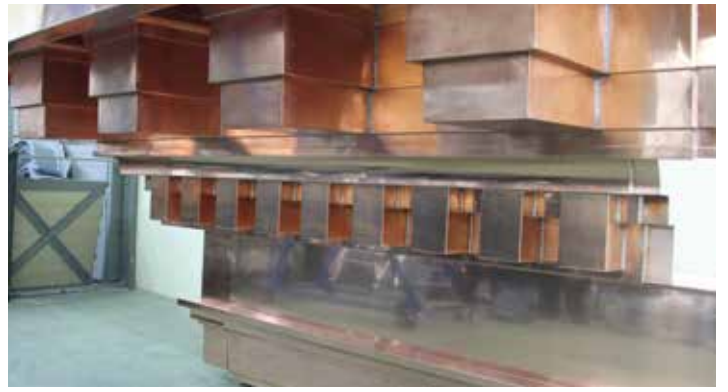
All of this was submitted for approval from the architects and contractors in charge of the project. In total, two hundred pieces clad the cornice along its entire perimeter. Fixing constraints were taken into account when designing the decor. It was necessary to anticipate problems during assembly. The cornice was cut into sections measuring two metres in length, assembled using mobile fixing clips enabling expansion, while at the same time allowing ventilation and evacuation of water produced by condensation. These points were examined by the VMZINC® R&D teams. Restoring the memory of Hadrian turned out to be a real technical challenge, a challenge met by all the teams to achieve a spectacular result.

Using historic documentation - plans and photos - the ornamental metal worker teams first developed a 3D model that was submitted to the project stakeholders. After validation, a life-size prototype made it possible to test assembly options for the various elements joining together to make up the cornice: ogee, counter-ogee, curves and counter-curves, a combination of 7 curb members forming an upper part more than three metres high. As imposing as it is, this work forms a base on which the most noble ornaments are installed: antefixes, oak garlands, lion heads... These pieces were produced using punching, with the benefit of 180 years of know-how. Artisan sculptors recreated clay ornaments based on plans, from which they took plasterwork models, the base of Zamak moulds for lamination of pieces.
